INSPECTION REPORT

# Leak Detection | Comprehensive Report

Job number DEMO-LEAK-001

Site address 1 Example Street, Demo Town

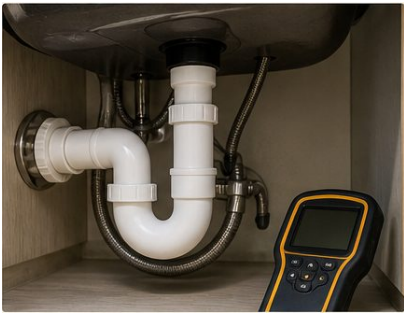
| Notable maintenance issues | Accessible supply and waste connections remained dry during the fictional basin test. |

Basin | Photo 1  
Vanity pipework - illustrative sample image, not evidence of a diagnosed leak
