# Roof Inspection | Comprehensive Report

Prepared for: Example Homeowner - FICTIONAL

| Job number | DEMO-ROOF-001 |
| Site address | 2 Example Street, Demo Town |

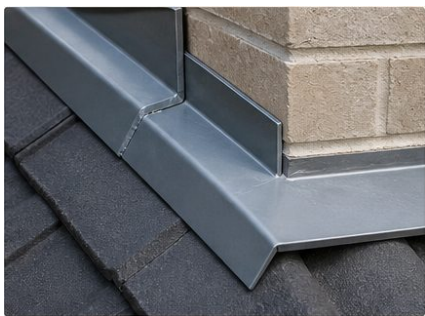
| MAIN BUILDING ROOF ASSESSMENT - FRONT ROOF ELEVATION | |
|---|---|
| Type of event-related damage observed | Damaged flashing |
| Event-related damage summary | Weathered sealant was observed at the illustrated flashing. This is a condition observation; event attribution remains unconfirmed. |

**Main building roof assessment - Front roof elevation | Photo 1**  
 Flashing detail - illustrative sample image; observations are supplied separately

| Recommendations | Arrange removal of the documented debris and assessment of the flashing detail, then inspect under controlled conditions. |
